1. REPORT NUMBER NI00042	2. GOVT ACCESSION NO. AD-A087276	3. RECIPIENT'S CATALOG NUMBER
4. TITLE (and Subtitle) Phase I Inspection Report National Dam Safety Program. Indian Mills Dam, Burlington County (NJ 00042) New Jersey, Atlantic Coast Basin.		5. TYPE OF REPORT & PERIOD COVERED (9) FINAL rept.

INDIAN MILLS DAM (NJ00042)

CORPS OF ENGINEERS ASSESSMENT OF GENERAL CONDITIONS

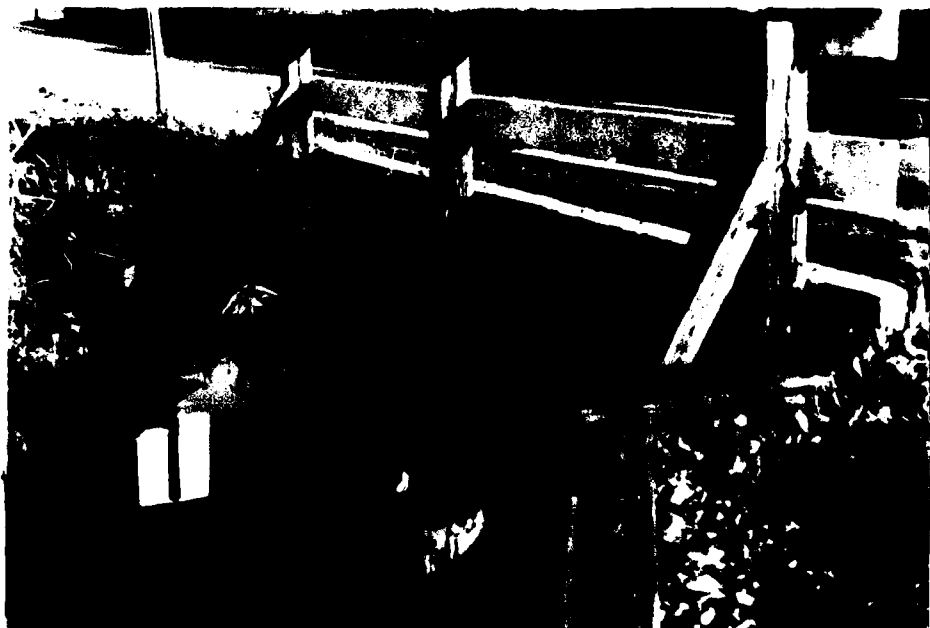
View of Road Culvert
Immediately Downstream of Dam
